MEMORANDUM

RE: Taxiway C Project Update & FFY24 Project Alternatives
SEH No. MINOT 175535 14.00

Taxiway C – Preliminary Design Project Update

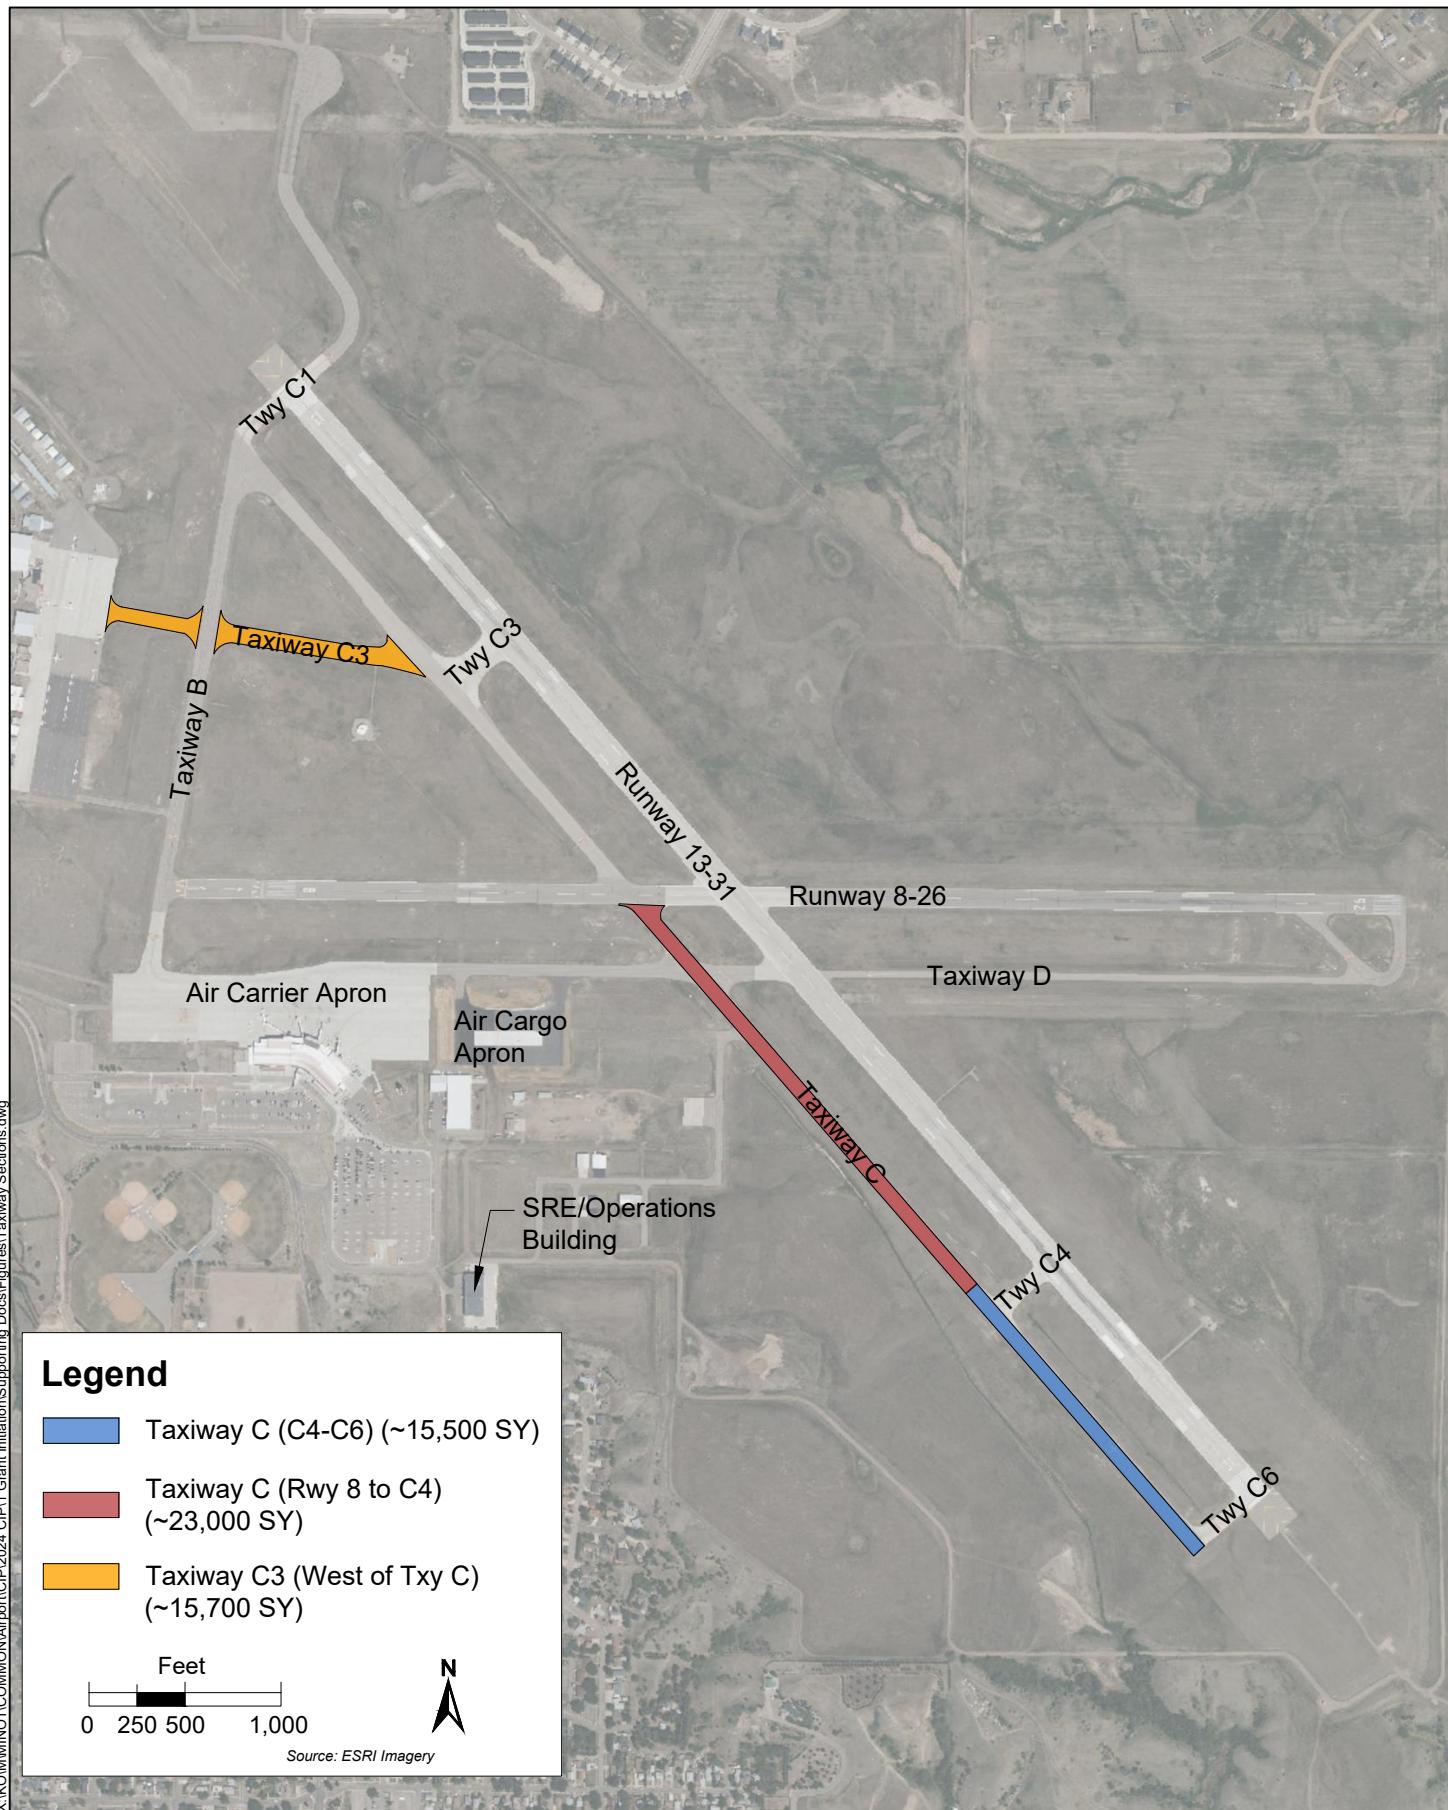
- **Existing Section:** 6.5"-7.5" of bituminous pavement, with underlying aggregate and granular base material.
- **Rehabilitation Discussion:** A rehabilitation for this section is feasible, however it is recommended that the section is strengthened via a 3" mill and 4.5" bituminous overlay. MOT's fleet mix includes aircraft over 100,000 lbs, which triggers the requirement (for new full section construction) of a 5" stabilized base and 4" surface course. Adding 1.5" of bituminous to this pavement section, per the above method, will increase the overall section to approach 8"-9" and is expected to add ~10 years to the useful life of the pavement, along with regular preventative maintenance. The pavement thickness at the intersections with C4 and C6 would remain at 6.5"-7.5" due to the need to match existing grades. See **Figure 1**.

The Taxiway C preliminary design effort began in early November with geotechnical borings to document existing site conditions and to determine if a rehabilitation project is feasible. The existing sections studied include (3) distinct segments, with existing conditions and rehabilitation feasibility summarized below, as well as in **Figure 1** and **Figure 2** attached to this memorandum.
