City Plate No.:
STO-13
Last Revision:
12/18/2020
Section:
2700

STANDARD DETAILS
PIPE JOINT REPAIR BAND

City of Minot

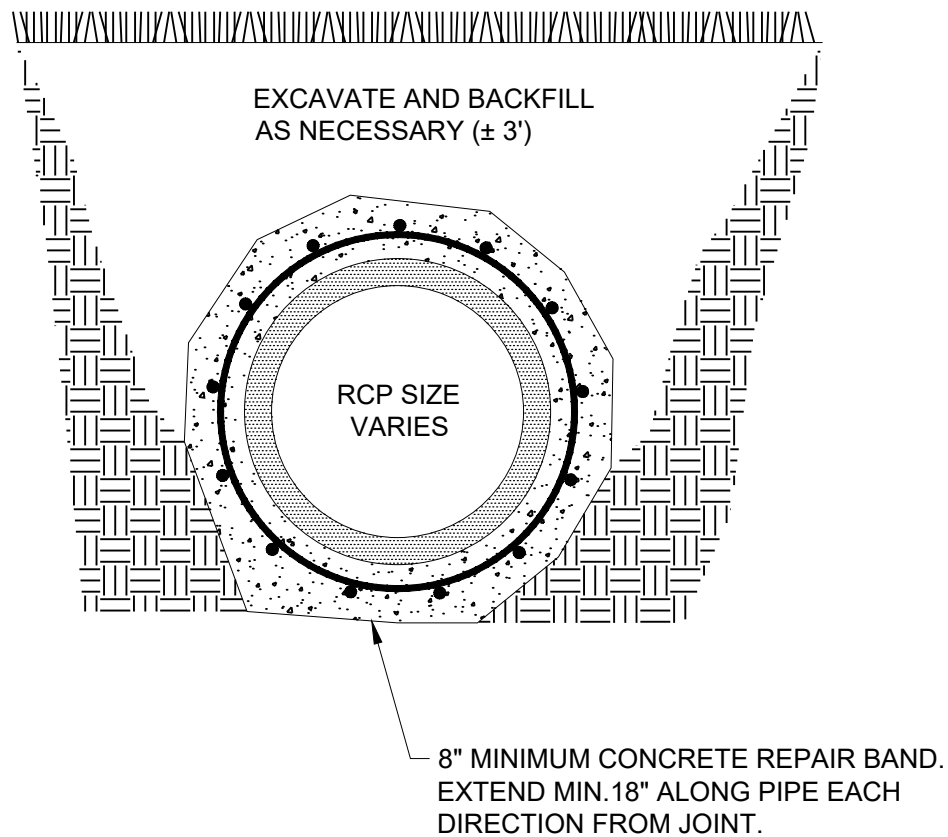
REINFORCING:

5 (MIN.) - NO. 4 DEFORMED BARS EVENLY SPACED (CIRCUMFERENTIAL)
NO. 4 DEFORMED BARS 12" O.C. (TRANSVERSE ACROSS JOINT)
